Figure 6: Segments of the Passaic River where 2008 and 2007 multibeam bathymetry data were compared based on average depth in a 3 ft by 3 ft grid spacing.

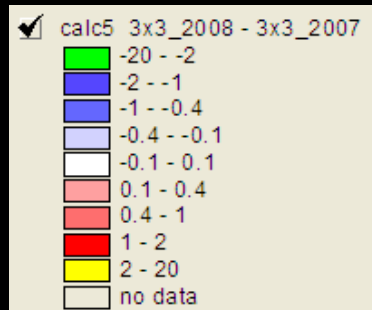
Figure 8d: Difference between 2007 and 2008 multibeam bathymetry (feet; negative deeper in 2008) for River Segment B (RM9.75) with transect location

*depressions on
either side of
bridge
shallower in
2008*

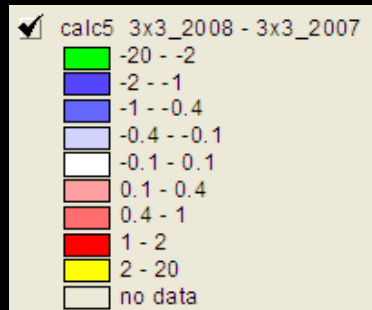
Figure 9d: Difference between 2007 and 2008 multibeam bathymetry (feet; negative deeper in 2008) for River Segment C (RM8.85) with transect location

*structure
beneath
bridge*

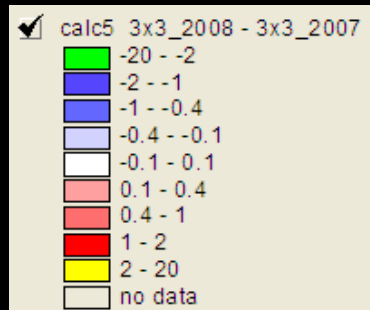
Figure 11d: Difference between 2007 and 2008 multibeam bathymetry (feet; negative deeper in 2008) for River Segment E (RM1.6) with transect location
